## On-line inspection of sealing compound in covering lid

### Measuring system setup: LD1605-2

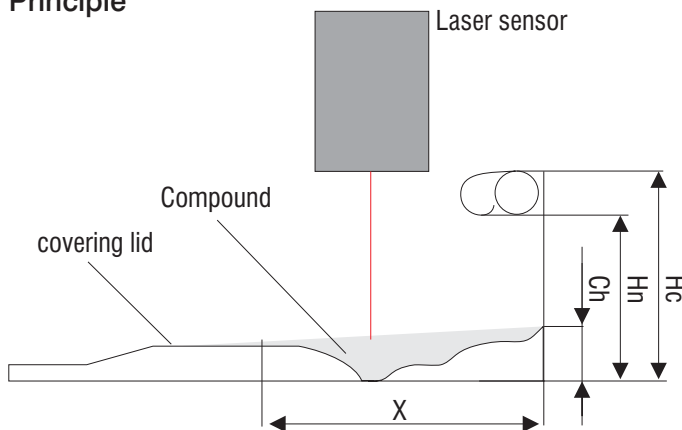
### Principle

After injection of the sealing compound in the covering lid, curing takes place in the tunnel furnace. Here, fault points and faulty thicknesses of compound must be acquired and faulty lids must be sorted out in the production process. A laser-based optical displacement measurement system samples the compound surface of the rotating lid for a quality inspection. The monitoring of the thickness contour within the permissible tolerance limits and the sorting of the faulty lids occurs with the aid of the PLC that is employed.

- Measuring range 2 mm
- Accuracy: 5/10 mm
- Resolution: 1/10 mm
- Bandwidth: 10 kHz
- reflecting target surface

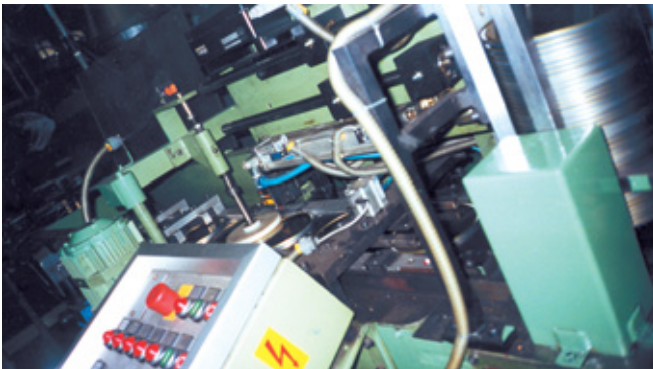
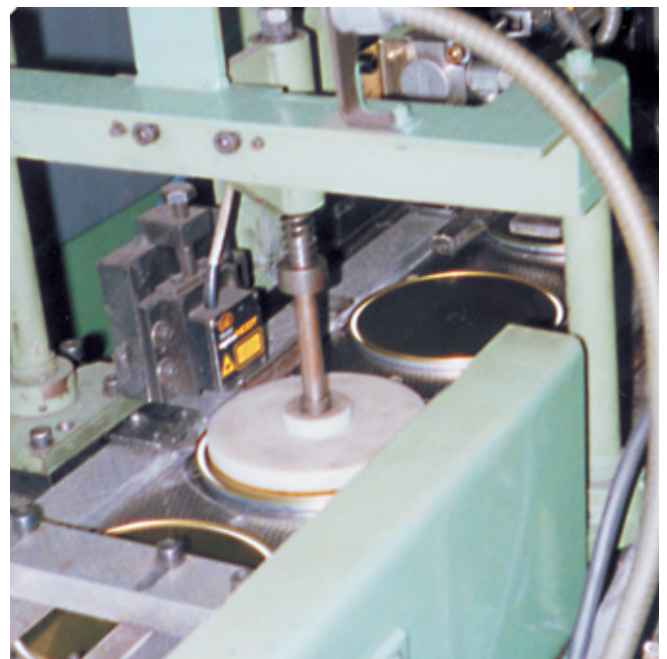
- Accurate, fast and reliable.
- Small light spot diameter.
- Non-contacting and therefore wear-free.
- Laser Protection Class 2.
